Are your carbide tips smiling back at you?

If so, it's time to replace them.

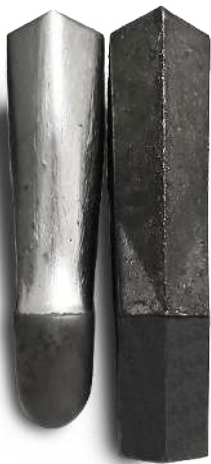
1

Is the tip rounded off and smiling back at you? In drier conditions, or in high compaction areas, a rounded off tip can cause poor penetration and lost bushels.

2

Does the tip show extreme wear on the sides or above the nose? If so, it could break off and cause holder damage.

3

Is there wear showing on the holder? Check for deterioration in hard surfacing and funnels closing in.

If you've answered yes to any of these check points, it's time to replace your carbide tips. Talk to your local BTT dealer, call BTT at 1.800.878.7714 or email info@tillagetools.ca.
